BUSH BULLETIN

Fatal accidents in logging, forestry and tree work

Logging truck trailer tips at low speed

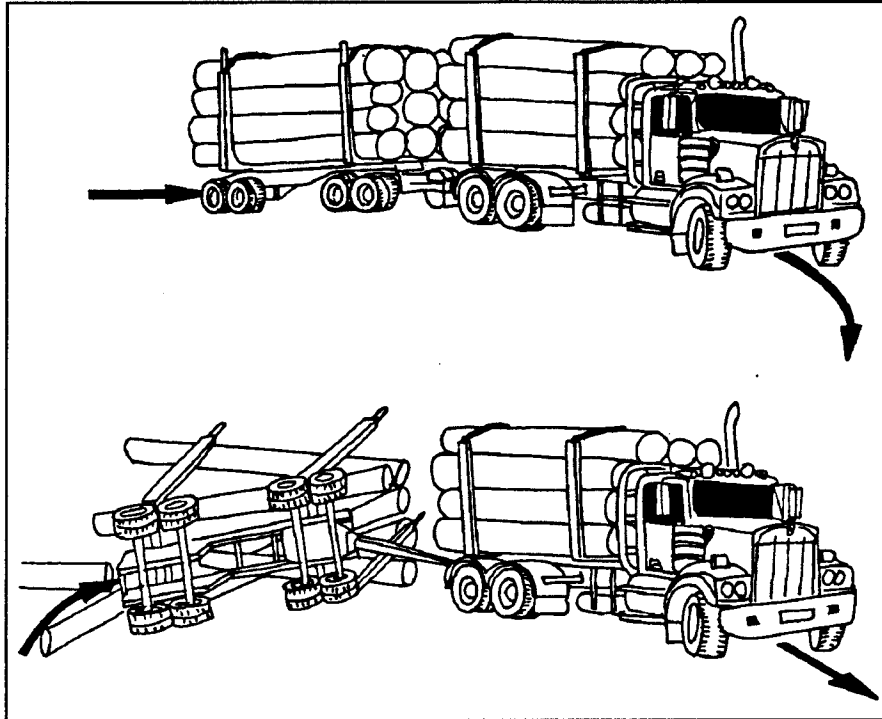
A logging trailer tipped as the truck and trailer made a right angle turn at a main highway junction.

A truck and trailer unit both carrying pulpwood, were turning at right angles around a traffic island from one state highway onto another. The intersection was clear of traffic and the driver was able to make the turn at what appeared to be a safe speed. However, the trailer started to tip part way around the island and eventually tipped and spilled its load onto the grass verge.

An examination showed tyre marks from almost the start of the turn and then gouge marks at about the apex of the turn suggesting that a front left tyre on the trailer was either flat, or certainly deflated, causing the tyre marks and the gouging of the road surface, and contributing to the trailer tipping over.

Another contributing factor is thought to be the incorrect loading of the trailer which had longer, heavier logs on the top of the load causing a top-heavy load situation.

The corner is also known for the camber which falls away from the road centre to the outside causing balance of the load and vehicle to be thrown to the outside of the turn.

- Trailer tyre deflation.
- Incorrect loading.
- Poor road shape.

1. Check and ensure that all tyres are correctly inflated and meet road transport standards.
2. When loading pulpwood, be careful to properly balance loads by, if possible, loading longer larger logs on the bottom of the load.
3. Be aware of incorrect, unusual or poor road shaping on your regular cartage routes and watch carefully for them if on a new route.
