BUSH BULLETIN

Hauler accidents

Incorrect guyline placement (based on a report supplied by Tasman Forestry Ltd.)

Main rope catches on stump causing guy anchors to fail (details from the company's investigation)

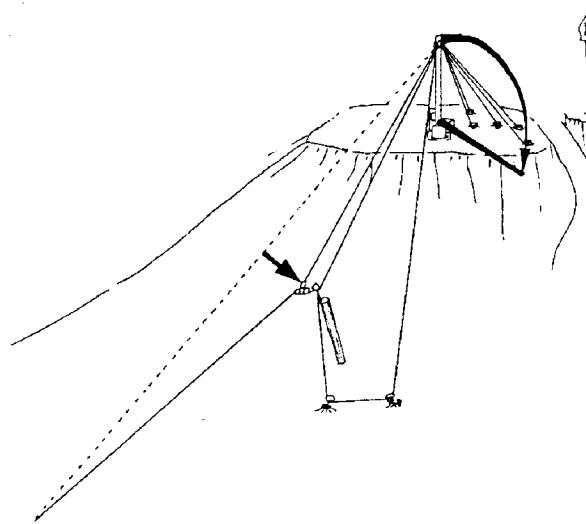
While bridling in a North Bend operation, the skyline deflected sideways towards the drag during mainline inhaul. Lateral support for the pole was so diminished that it toppled over sideways. The diagram shows the actual position of the guylines around the pole and the positions of the various ropes at the time of the accident.

Lack of attention to the correct guyline and hauler positioning, and added hazard while bridling.

At least one guyline should have been positioned in the empty quadrant to the west of the hauler. The alternative was to reposition the hauler and completely reposition the guylines. There is a need for increased focus on hauler and guyline positioning, especially when bridling.

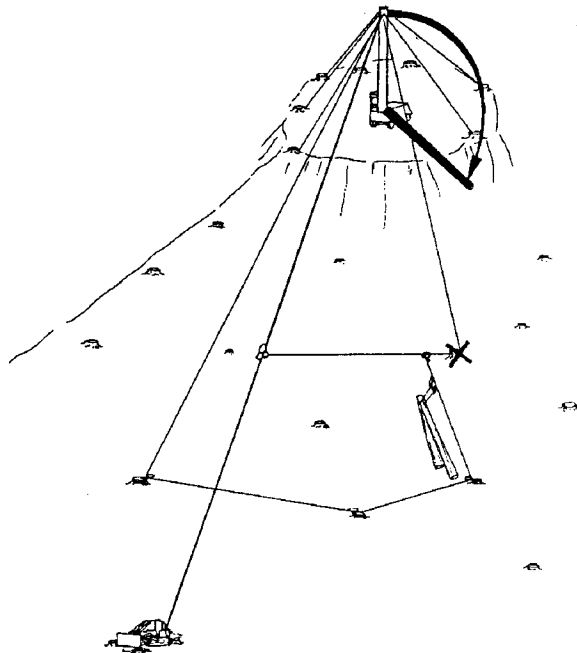
In a North Bend operation, it was necessary to bridle 50 metres from the skyline. At inhaul, the main rope became hooked behind a stump but the hauler operator continued to apply pull. He was not stopped by the breaker-outs and, as a result, the guy stump directly behind the line of haul was pulled out. In a chain reaction, another stump was pulled out and two guy stumps were sheared. This resulted in the tower and hauler tipping over.

The investigation found that the causes of the accident were:

Major:

1. Main rope caught behind stump and hauler operator continued to apply pull.

Breaker-outs did not stop hauler operator.

2. The guy ropes were not changed around after a large change in the angle of pull.

1. Heavy rain the previous day probably weakened the stumps.
2. The roots of one stump were damaged from previous logging.
3. Breaker-outs were using the whistle in place of the usually-used radio, so there was no voice contact.

1. As in the other hauler accident reported, more care should have been taken in the positioning of the guy ropes with the change in angle of the pull.
2. The breaker outs should have been alert to what was happening and signalled the hauler operator to cease the pull.
