Skidder Tipped Over By Runaway Tree Stem

Compiled from Carter Holt Harvey Forests' Northern Region accident report.

Skiddy Caught in Sudden Tension on Strawline

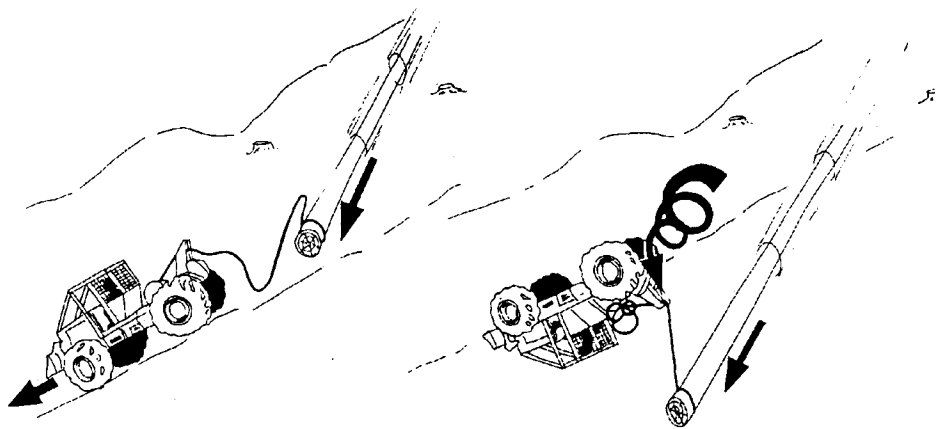
Unfortunately, the rope bird nested and bound. The momentum the stem had gained pulled the rear of the skidder around and the machine tipped over.

The operator misjudged both the size of the stem and the best location to position the skidder for maintaining control over the drag during breakout.

Lack of control over the drag during breakout enabled the stem to gain speed rapidly and it was of sufficient size (15.1 tonnes) to pull the skidder over when the winch rope bird nested and tightened.

- Formal debrief between the company and contractor.
- Review of circumstances surrounding this incident with emphasis on hazard awareness.
- The ongoing development of safety management systems within the contractor's firm.
- The pre-emptive cutting of large stems prior to extraction in this block.
- The completion of training and the attainment of the relevant FIRS module for this type of work by the skidder operator. (Work experience 5 years and 10,000 hours.)
- If someone suffers a heavy head blow, the helmet should be taken to the doctor to inspect as this may help with the diagnosis i.e. indicate force and direction of blows.

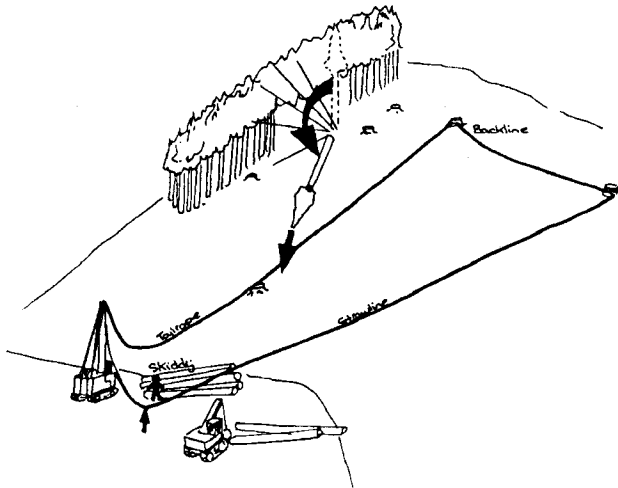
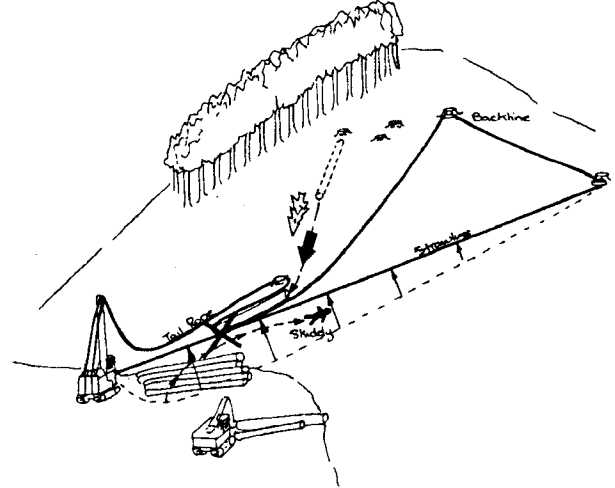
A skid worker was caught and thrown a considerable distance by the strawline as sudden tension occurred.

The broken end of the log became entangled in the tailrope and pulled it downhill at increasing speed. The tailrope then caught around a stump which acted as a double purchase and suddenly tightened the attached strawline.

The skiddy was working over the strawline on the landing and was thrown 40 metres away in an uphill direction as the strawline suddenly tightened. He suffered a fractured jaw, collarbone, rib and arm as well as a punctured lung and lacerations.

The accident was caused by the felling and subsequent downhill slide of the felled tree. The employer had identified logs sliding downhill towards

- On a downhill setting where there is no barrier between the stand and the landing (e.g. gully around the edge of the landing), all felling should take place before setting up the hauler.
- Where it is not practicable as above, no activities shall be undertaken while felling is in progress and all workers not involved in the felling process shall move to a pre-identified safety zone and maintain a watch for log movement.
- On an uphill extraction setting, no felling should take place within two tree lengths of any ropes, whether suspended or on the ground, moving or stationary, or while the breakerouts are below the line of the felling face. Hauler ropes will be stationary and all personnel in a predetermined safety zone before felling commences.
- Workers should not leave the designated safety zone until the faller signals it is safe to do so.
