Forestry Bulletin

Skyline Cable Tensioning System Results in Logger's Death

Loader Driver Killed When Machine Tips

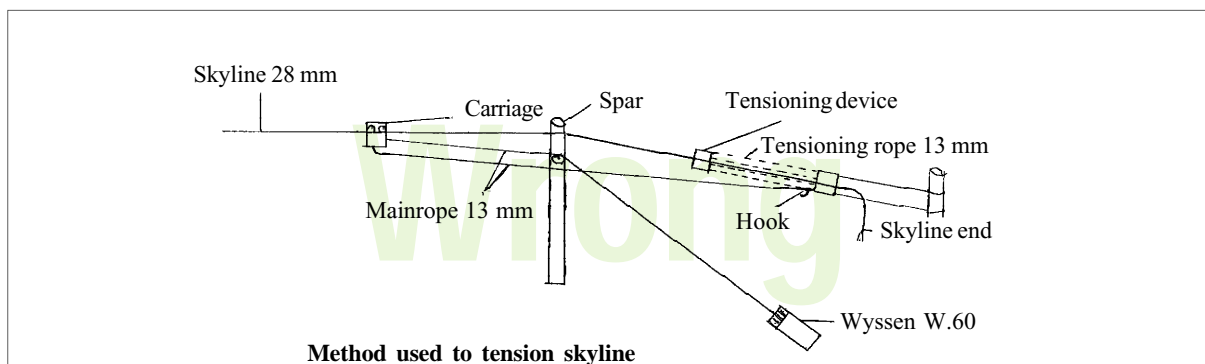
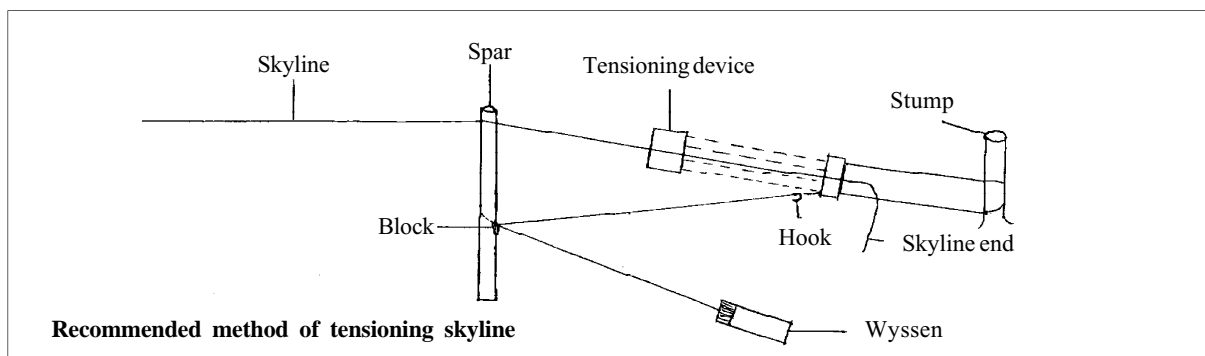
A crew in a Wysenn skyline operation was working on tensioning the cable before work started for the day. It was noticed that the cable was hooked under the arm of the hi-ab on the barge and the crew immediately began to de-tension the cable to release it from the hi-ab.

During this procedure, the carriage, which was being used in the tensioning, tilted, slipped along the

skyline and the hook became airborne and struck the worker.

The Havelock coroner, Colin Mcnab, listened to details of two systems of tensioning the skyline, one using the carriage and winch and the other the direct use of the winch only. He found that the method using the carriage had caused the accident which had resulted in loss of a life and asked that OSH circulate logging contractors with the appropriate method of tensioning the Wysenn skyline. This is illustrated in the bottom diagram.

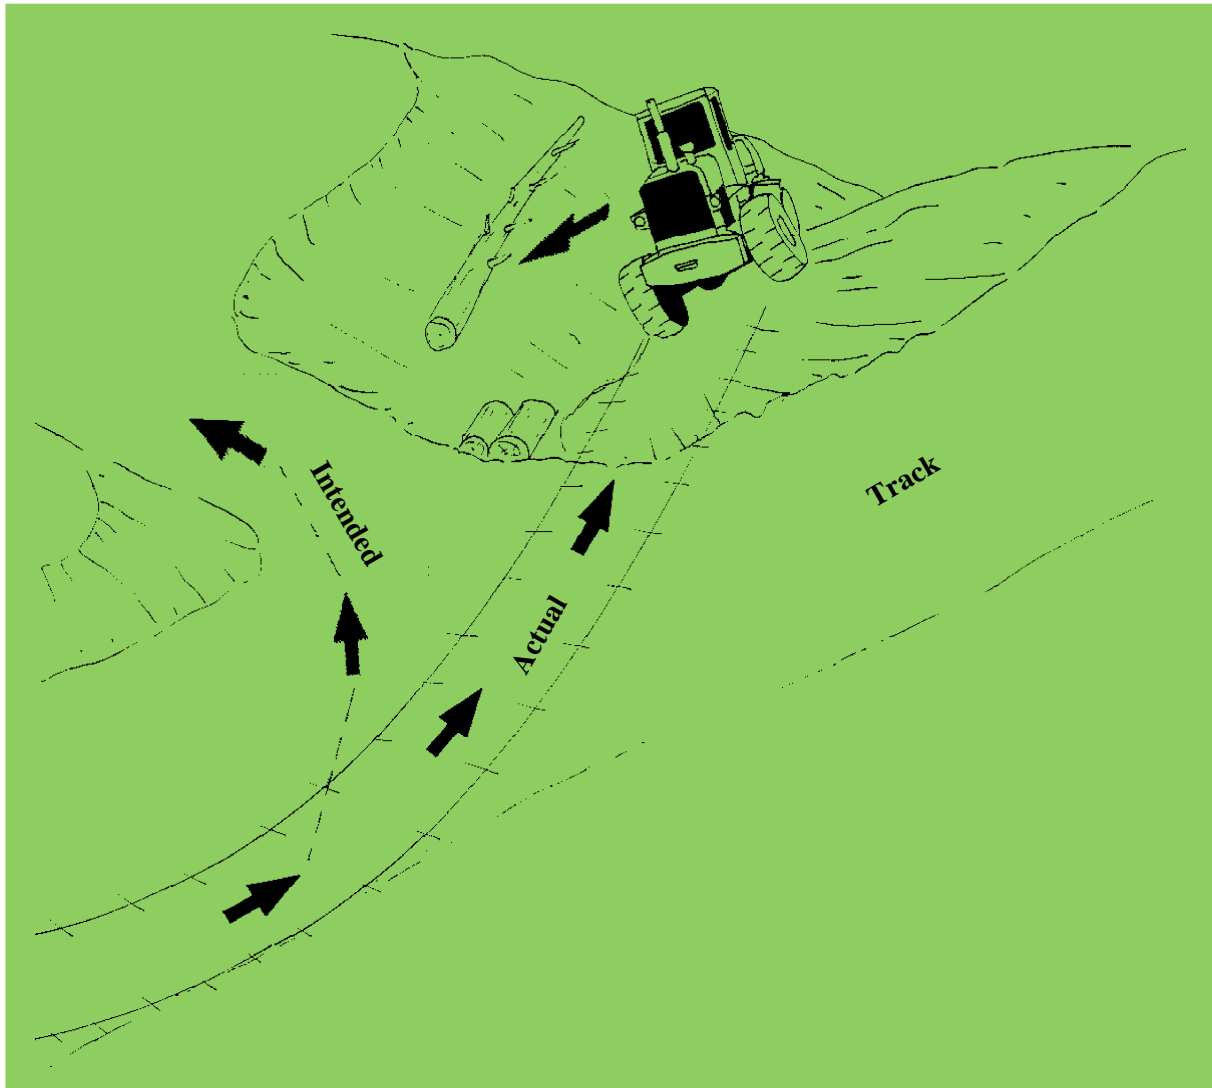
A truck driver suffered fatal injuries from being crushed when the front-end loader he was driving between skids went off the road and tipped.

A truck driver, working alone, had loaded his truck and was driving the front-end loader to the adjacent skid about 60 metres away. He failed to take a sharp left-hand turn from the road into the skid and drove into a steep-sided gully, passed over a log near the start of the gully and ended up 10 metres from the road. Evidence showed that the loader had tipped over on its left side damaging the ladder and left side. It gouged out earth along the gully side and then righted itself and came to rest on all four wheels. The driver was found under the loader with his right arm under the rear left-hand wheel. It appears he had been thrown out as the loader tipped and was crushed between it and the gully sides.

Examination of the loader after the accident showed that the front brake master cylinder was empty of fluid. This could have halved the braking efficiency of the machine.

The emergency braking system was fully operative and had not been activated during the accident. There were thoughts that the driver, although an experienced machine operator over 30 years, may not have been familiar with the model concerned.

The investigating OSH officers were unable to pinpoint the accident cause although partial brake failure and unfamiliarity and judgement error could have been contributing factors.

The accident probably would have resulted in minor injuries, not a fatality, if a seat belt had been fitted and worn.
