Operator Protection Against Chain Shot

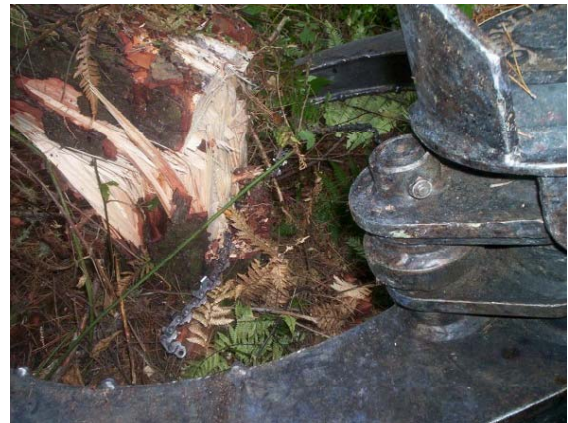
In April 2004 an operator of a mechanised harvester was seriously injured when the $\frac{3}{4}$ -inch saw chain of the felling head broke, firing a piece of chain through the front window of the machine fracturing the operator's skull. Other 'chain shot' accidents have since occurred.

The speed of the chain and the energy created as the broken chain whips around can cause pieces of the chain to break away and be thrown at a high speed equivalent to that of a rifle bullet.

Felling head showing broken chain

Following this accident, the local manufacturers of mechanised felling and processing attachments designed and fitted a deflector device to their respective saw units based on a recent Swedish research study. No such deflector device was available in New Zealand at the time of this accident.

- Ensure a 12.7 mm or greater polycarbonate or laminate equivalent front OPS window is installed.

- Ensure operators and bystanders stay clear of the plane of the saw bar when operational.
- Control chain's speed to below 35 m/s for $\frac{3}{4}$ -pitch chain or 40 m/s for 0.404-pitch chain.
- Install a chain shot guard near the drive sprocket.
- Inspect chain frequently and remove damaged or cracked chain from service.
- Remove dull chain from service.
- Maintain proper bar and chain lubrication and chain tension.
- Replace the drive sprocket when visibly worn.

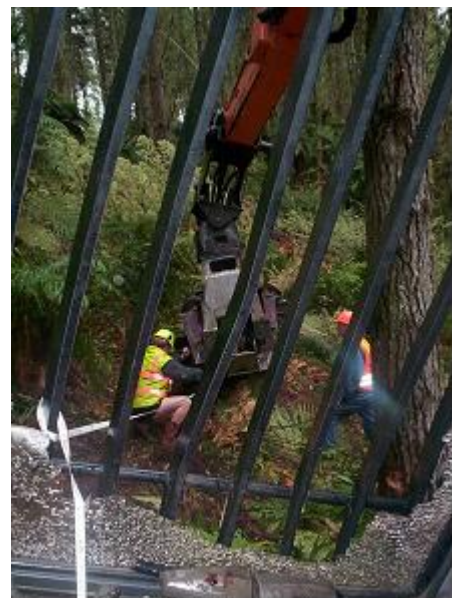
View from inside operator's cab

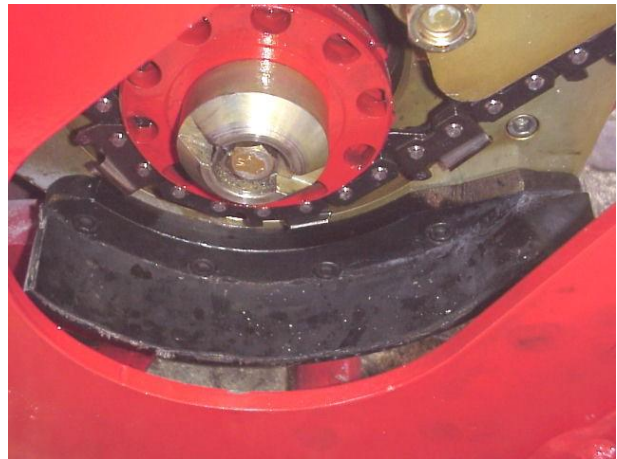
Deflector and chain catcher peg

Photo taken from Waratah Safety Information Bulletin
