BUSH BULLETIN

Hauler accidents

Incorrect guyline placement (based on a report supplied by Tasman Forestry Ltd.)

Main rope catches on stump causing guy anchors to fail (details from the company's investigation)

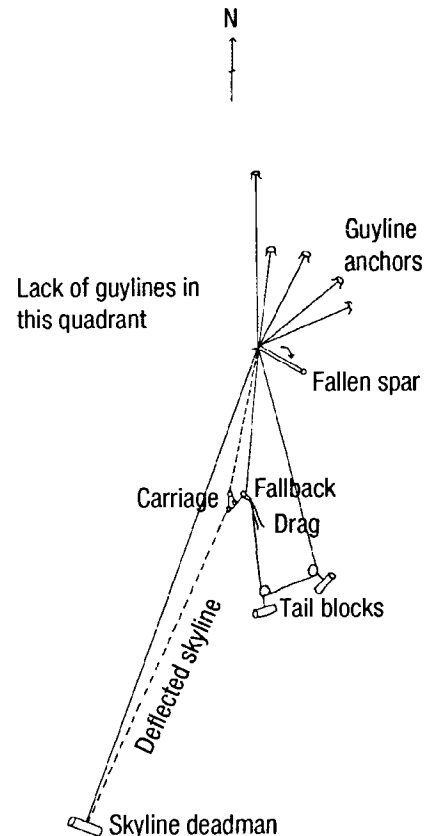
While bridling in a North Bend operation, the skyline deflected sideways towards the drag during mainline inhaul. Lateral support for the pole was so diminished that it toppled over sideways. The diagram shows the actual position of the guylines around the pole and the positions of the various ropes at the time of the accident.

Lack of attention to the correct guyline and hauler positioning, and added hazard while bridling.

At least one guyline should have been positioned in the empty quadrant to the west of the hauler. The alternative was to reposition the hauler and completely reposition the guylines. There is a need for increased focus on hauler and guyline positioning, especially when bridling.

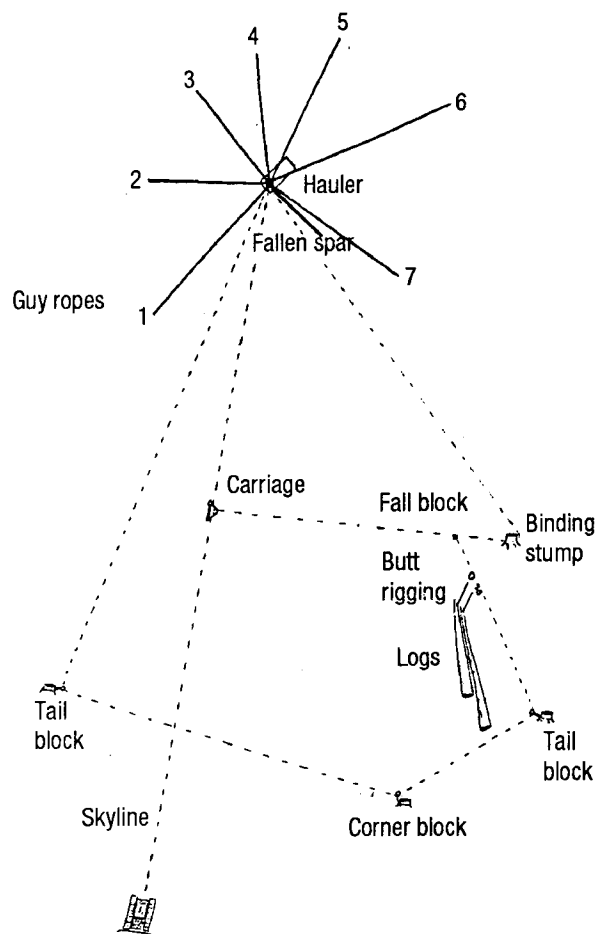
In a North Bend operation, it was necessary to bridle 50 metres from the skyline. At inhaul, the main rope became hooked behind a stump but the hauler operator continued to apply pull. He was not stopped by the breaker-outs and, as a result, the guy stump directly behind the line of haul was pulled out. In a chain reaction, another stump was pulled out and two guy stumps were sheared. This resulted in the tower and hauler tipping over.

1. Main rope caught behind stump and hauler operator continued to apply pull.

Breaker-outs did not stop hauler operator.

2. The guy ropes were not changed around after a large change in the angle of pull.

1. Heavy rain the previous day probably weakened the stumps.
2. The roots of one stump were damaged from previous logging.
3. Breaker-outs were using the whistle in place of the usually-used radio, so there was no voice contact.

1. As in the other hauler accident reported, more care should have been taken in the positioning of the guy ropes with the change in angle of the pull.
2. The breaker outs should have been alert to what was happening and signalled the hauler operator to cease the pull.
