General Workplace Inspectorate

ACCIDENT/INCIDENT ALERT

3 June 2004

Tyre Fitter Killed by Exploding Tyre

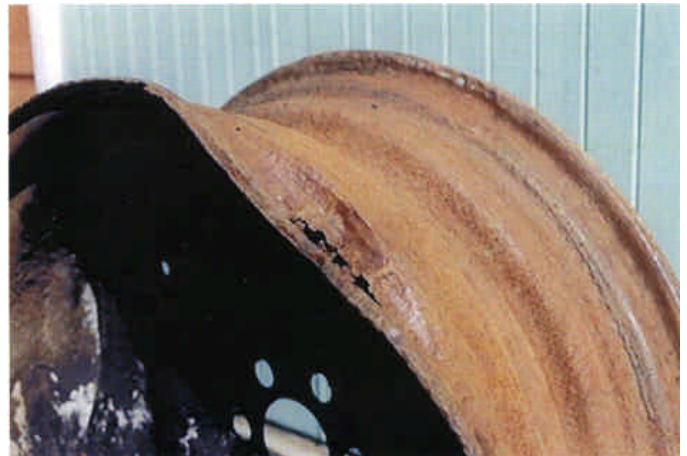
The wheel rim was severely corroded, with much pitting and some rust holes. This had weakened the rim edge, allowing it to fold inwards under pressure of inflation.

Photo of the wheel rim showing rust holes and folding in of rim edge.

Damaged or heavily rusted wheel rims should be rejected.

A suitable safety cage is required for the inflation of all large tyre/wheel assemblies or tyre/wheel assemblies for high-pressure tyres.

When a tyre cage is not available, the tyre should be restrained by some other safe method.
